# **EXPLOSION AT BLAENHIRWAUN COLLIERY, CARMARTHENSHIRE**

On the causes of, and circumstances  
attending, the explosion which occurred at  
Blaenhirwaun Colliery, Carmarthenshire,  
on 6th September, 1955

**T. A. JONES, O.B.E.,**  
*H.M. Divisional Inspector of Mines*

*Presented to Parliament by the Minister of Power  
by Command of Her Majesty  
November 1957*

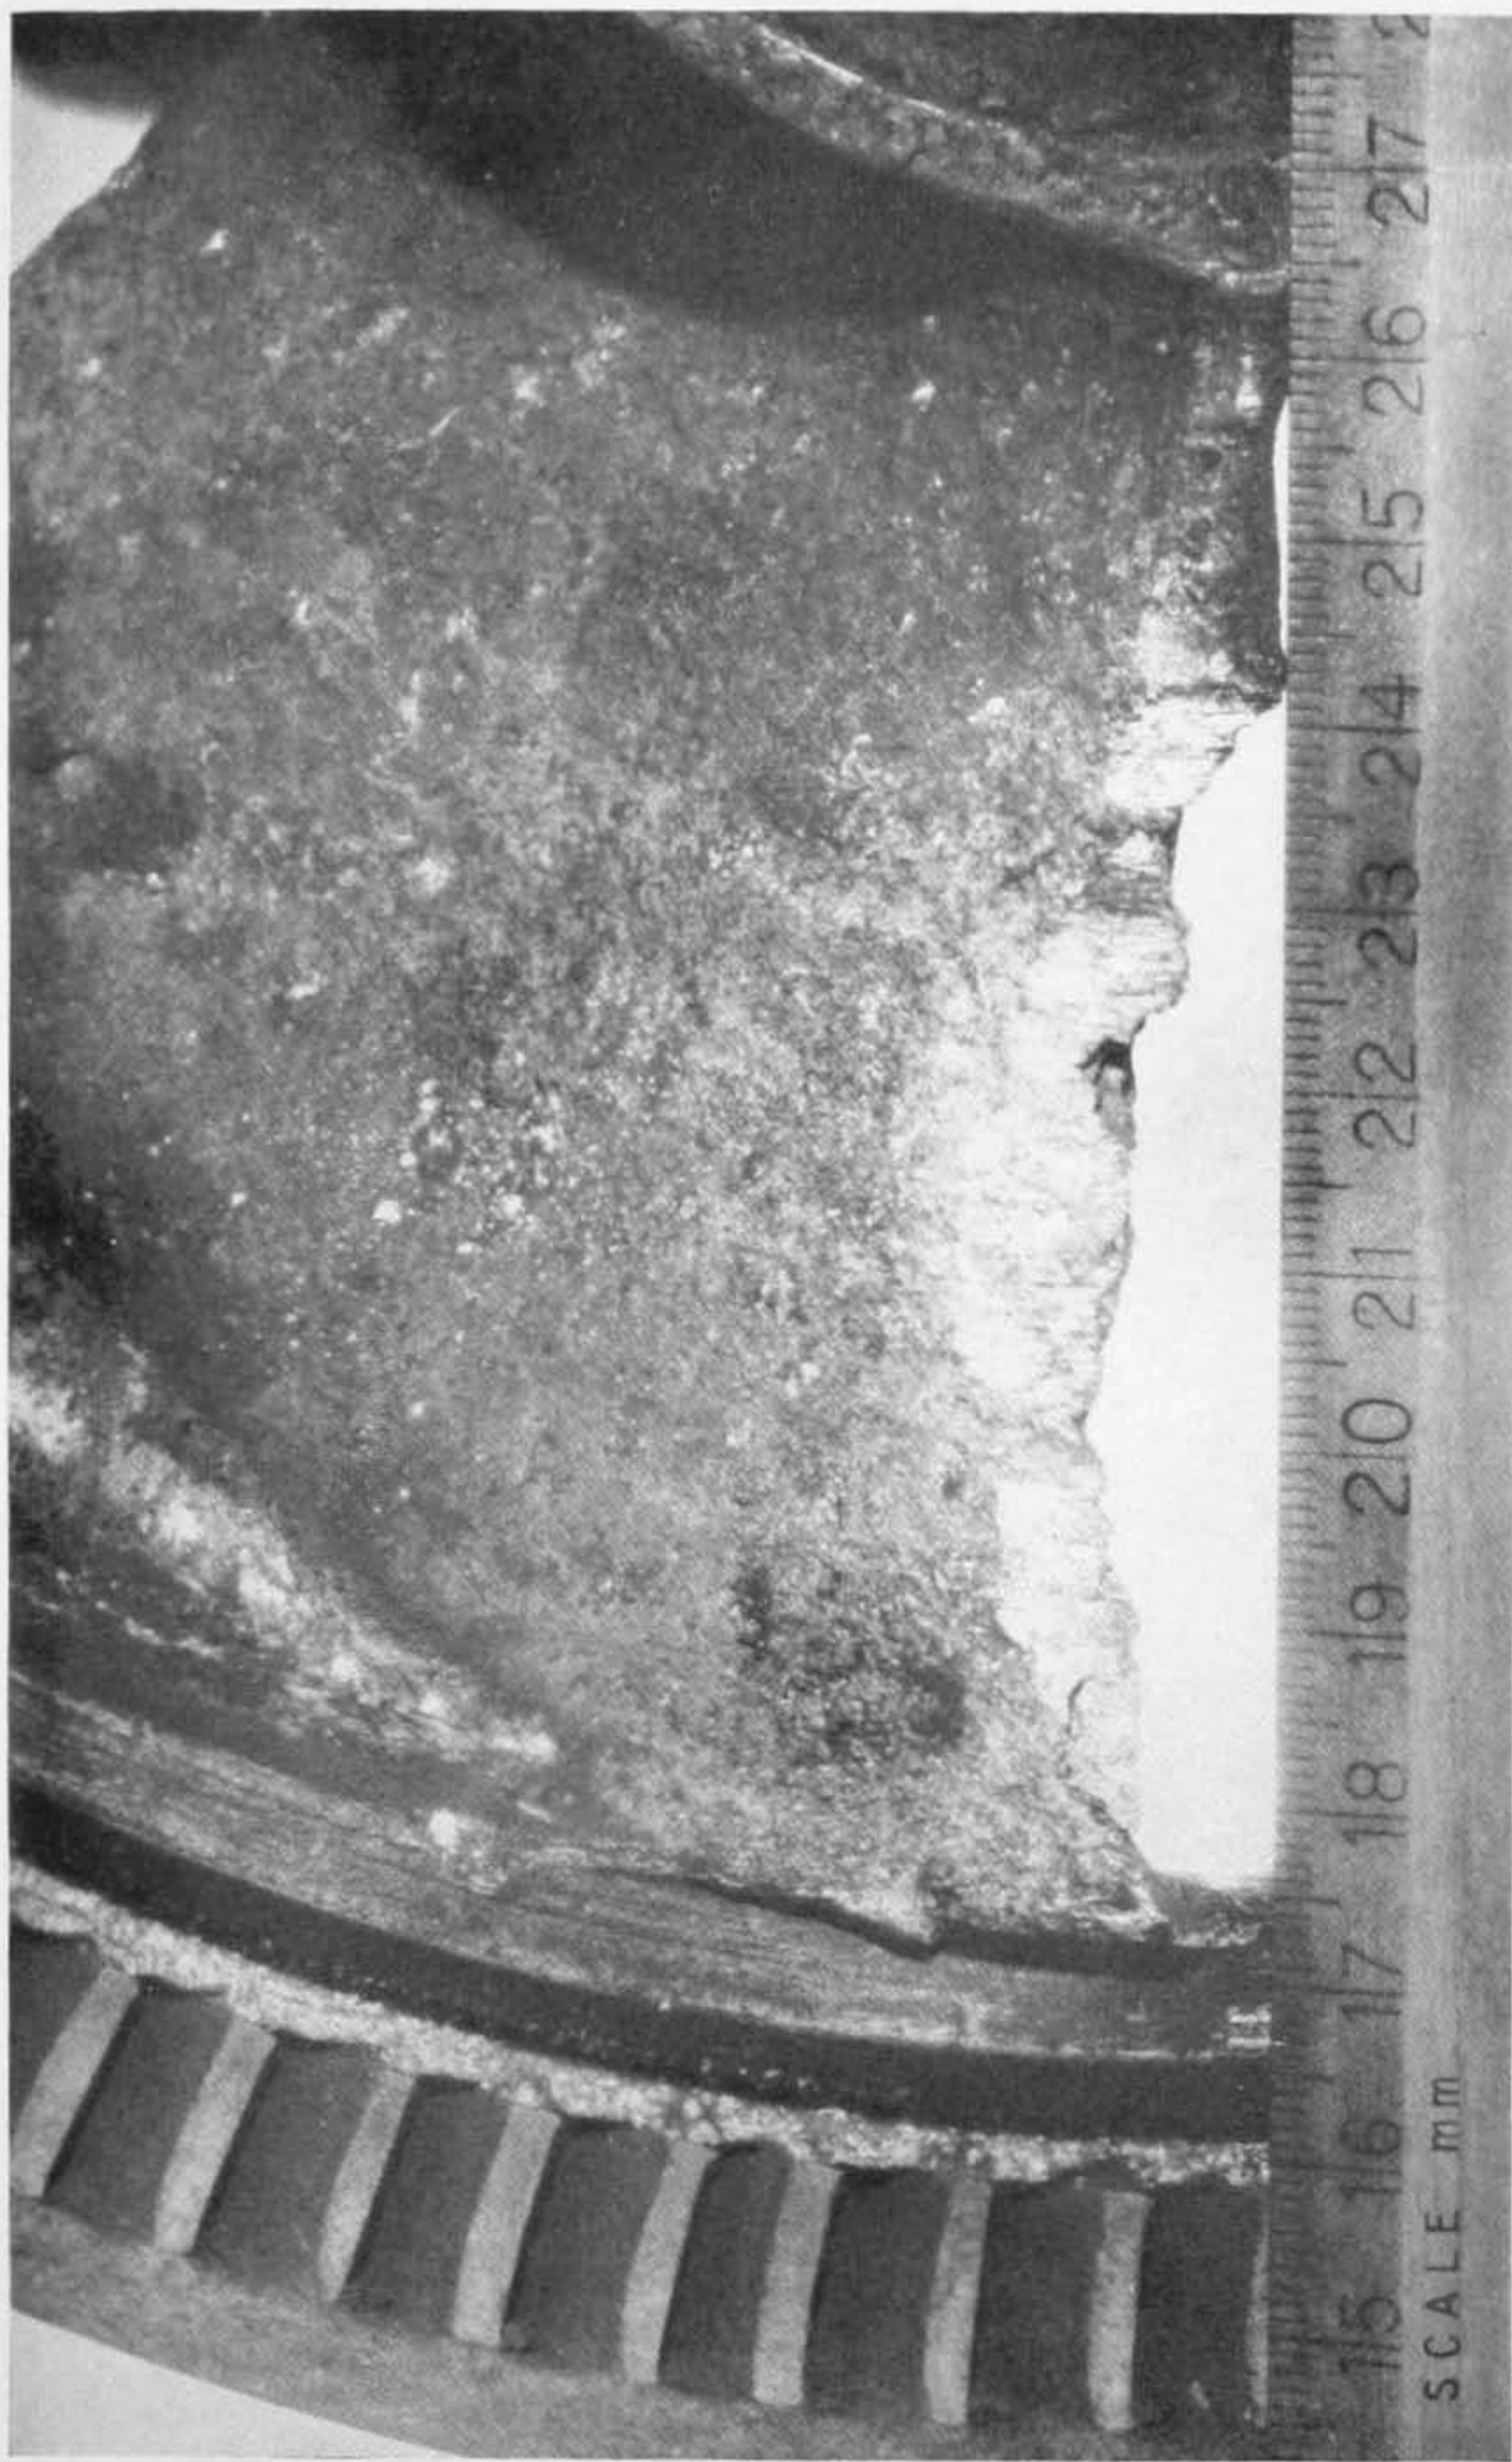
PLATE I.—Fan blade showing results of the abrasion and the embedded fragments of stone (see page 8).

This was a Mecro, Type CF3, compressed-air driven, four-bladed fan, 12 inches in diameter, in which both rotor and casing were made from an aluminium alloy. It was sent exactly as it was found after the explosion to the Safety in Mines Research Establishment where tests showed it to be in good running order. There were no signs of the rotor having fouled the stator, but each of the four blades showed considerable damage by abrasion of its trailing edge, and microscopic examination revealed small fragments of rock embedded in the aluminium of the blades where recent abrasion had occurred. In one case a fragment of stone was found embedded in caked dust near the tip of the blade.

A photograph taken at the Safety in Mines Research Establishment and included with this report shows the results of the abrasion and the embedded stone (see Plate I).

The only feasible explanation of this damage seemed to be that, when the fan was running in the supply gate, the rotating blades had rubbed against pieces of stone which had entered via the outlet ducting and come to rest against the spiders of the fan casing so as to foul the trailing edges of the rotating blades. With the ducting lying at the steep gradient of the gate and with the outlet pointing to the ripping lip while the ripping shots were fired, the presence of pieces of stone in a position to foul the trailing edges of the blades is easily explained. Furthermore, one of the men working at the supply gate rippings stated in evidence that, a few minutes before the explosion occurred, he noticed that the fan appeared to be running sluggishly, so he struck the fan casing with an iron bar whereupon the fan picked up speed. He had done this on previous occasions under similar circumstances and always with the same result. The obvious explanation is that stones from the ripping shots had been projected into the outlet ducting and were fouling the fan blades, thus causing the sluggish running; a blow on the casing moved the stones and allowed the fan to pick up speed. The stones would, of course, still be in position to foul the blades.

At the Safety in Mines Research Establishment to carry out frictional sparking tests with the fan itself, but experiments were carried out in which discs of an alloy similar to that used for the fan blades were made to rotate under very light pressure in contact with pieces of stone obtained from the supply gate rippings. These experiments proved that at rubbing speeds less than those which would occur in the normal running of the fan, sparks were produced which readily ignited a methane air mixture.

Another important feature of the occurrence is that it directs attention to the hazard of frictional sparking caused by foreign bodies coming into contact with the rotating blades of a fan. In this case the blades were made of aluminium alloy, but it would appear that the hazard would be much the same if the blades were made of iron or steel. If the ducting leading from such a fan is inclined upwards there must always be a possibility that any foreign body entering the open end of the ducting will gravitate to the fan blades. Most, if not all, of these fans are fitted by the manufacturers with a wire mesh guard on the inlet side; it would be a wise precaution if all these fans were fitted with a guard on both inlet and outlet sides. If the apertures in the mesh were as small as practicable, this particular hazard would be reduced to a minimum.

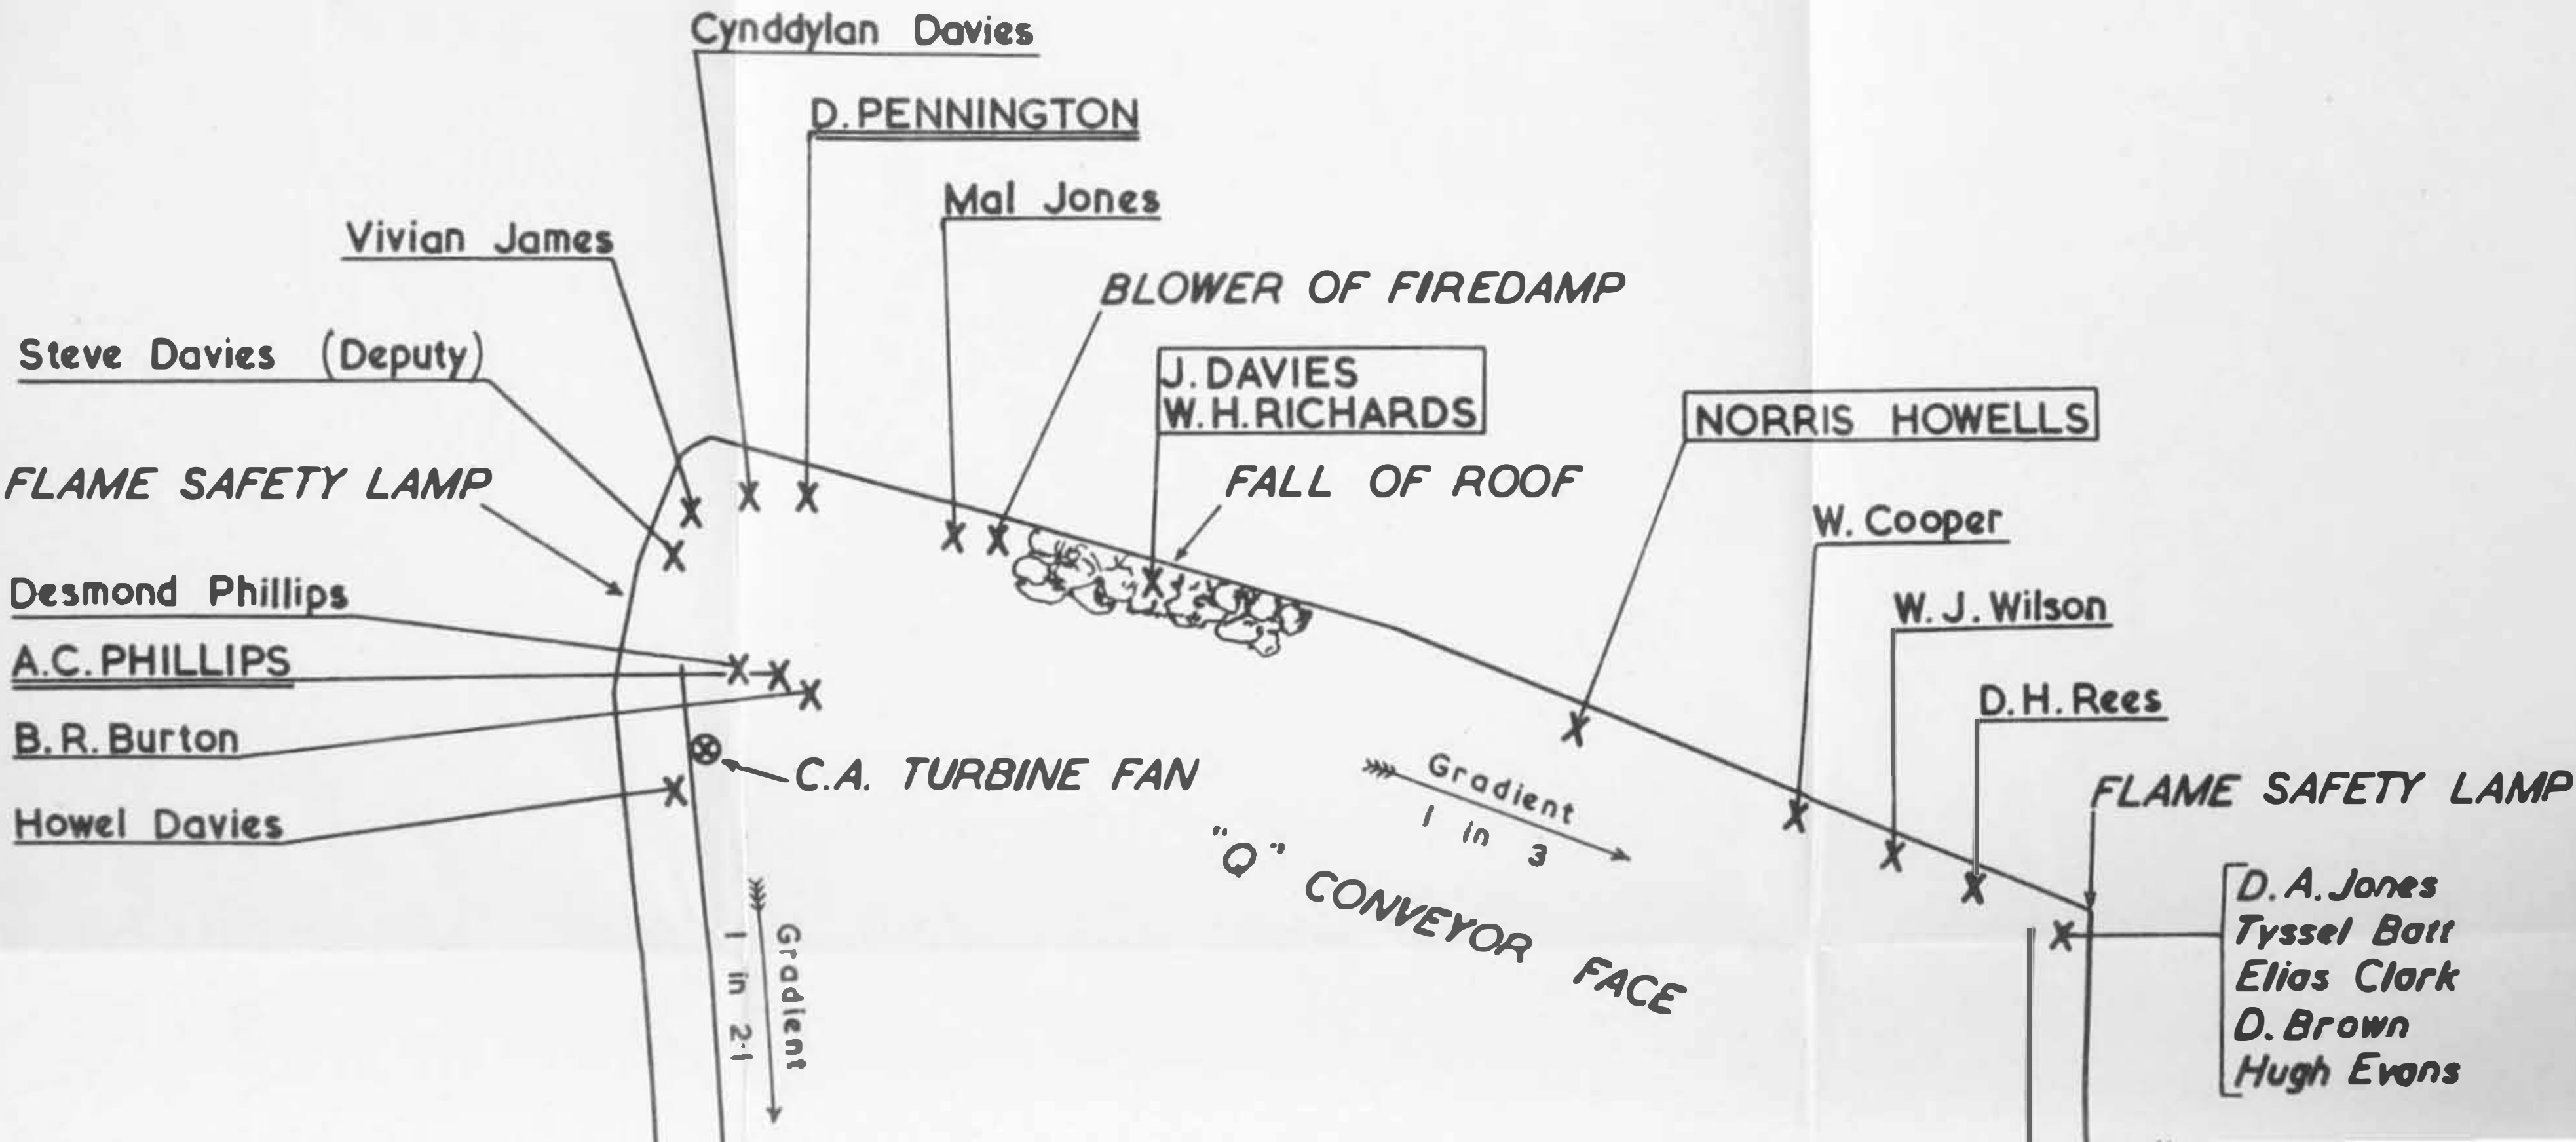
PLAN SHOWING POSITIONS OF MEN AT TIME OF THE EXPLOSION

The positions of the persons in the affected area at the time of the explosion are shown on Plan No. 2.

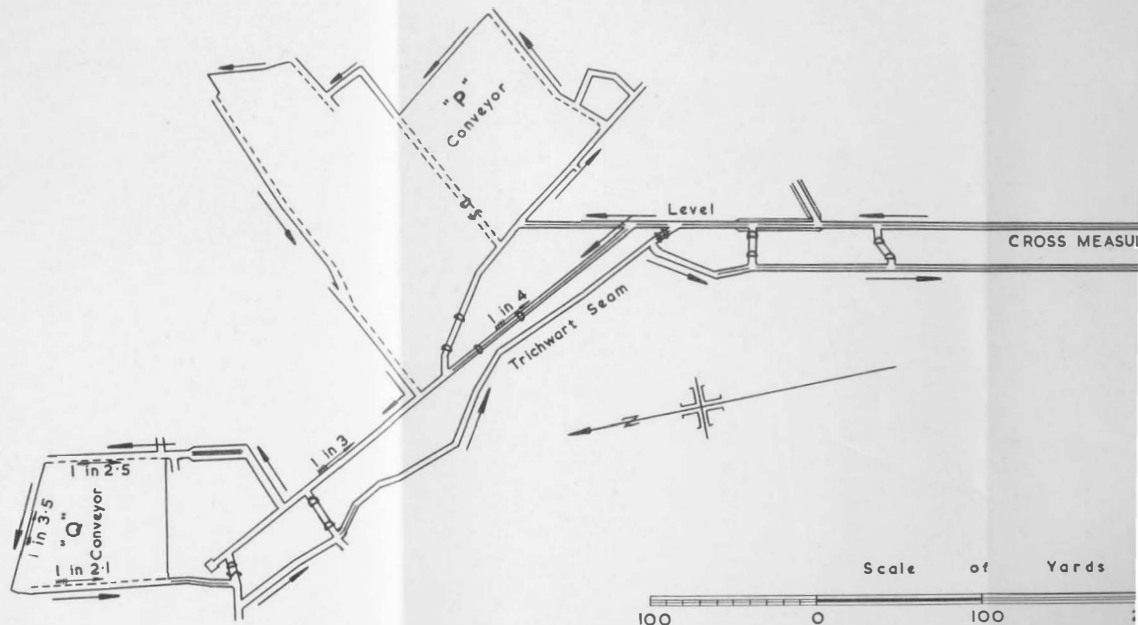
## PLAN OF WORKINGS IN LOWER PUMPQUART SEAM

At the time of the explosion the workings in the seam consisted of two longwall, single-unit, conveyor faces, known as the " P " and " Q " faces respectively. These faces were ventilated in series, the air current first entering the " P " face as shown on Plan No. 1.
